REPORT 51794/G

**TESTING OF
THREecastLES LIMESTONE
(1st QUALITY)**

McKeon Stone Limited
Brockley Park
Stradbally Park
Co. Laois
Ireland

29 July 2014

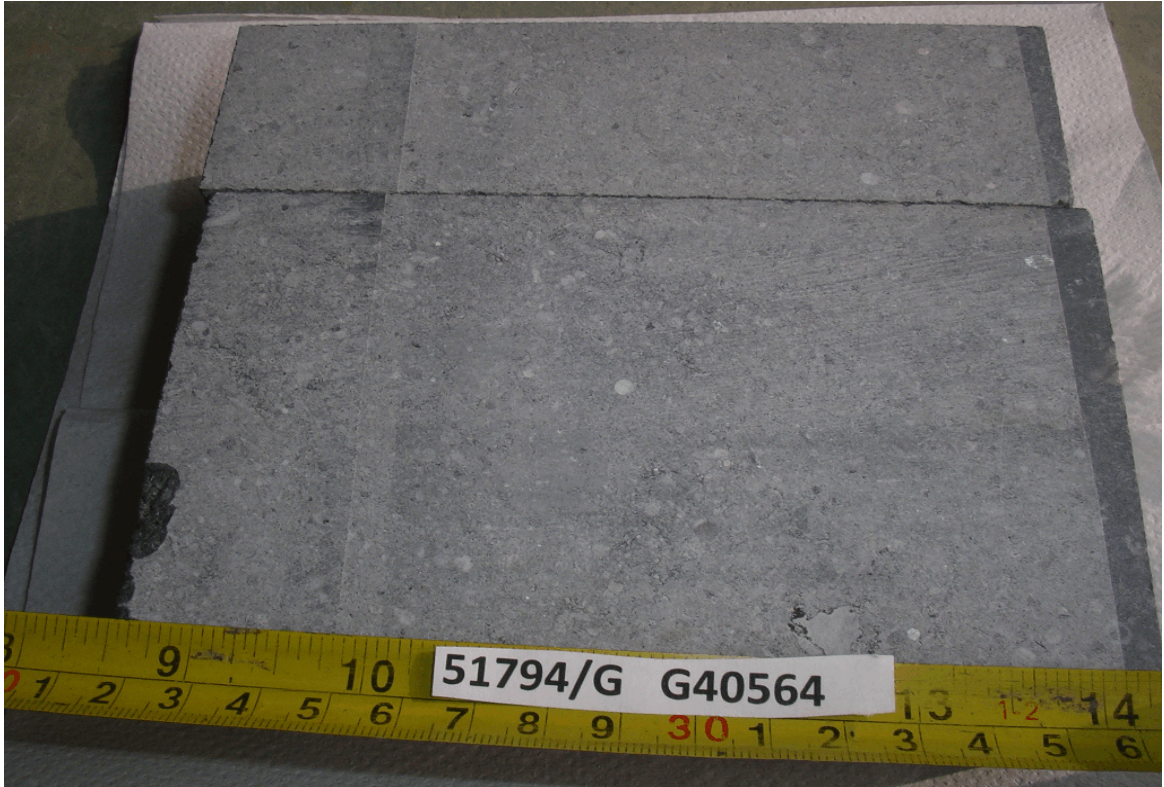
G40564 : Threecastles limestone. General view.

Record photographs of honed surfaces of the sample are presented in Table 1.

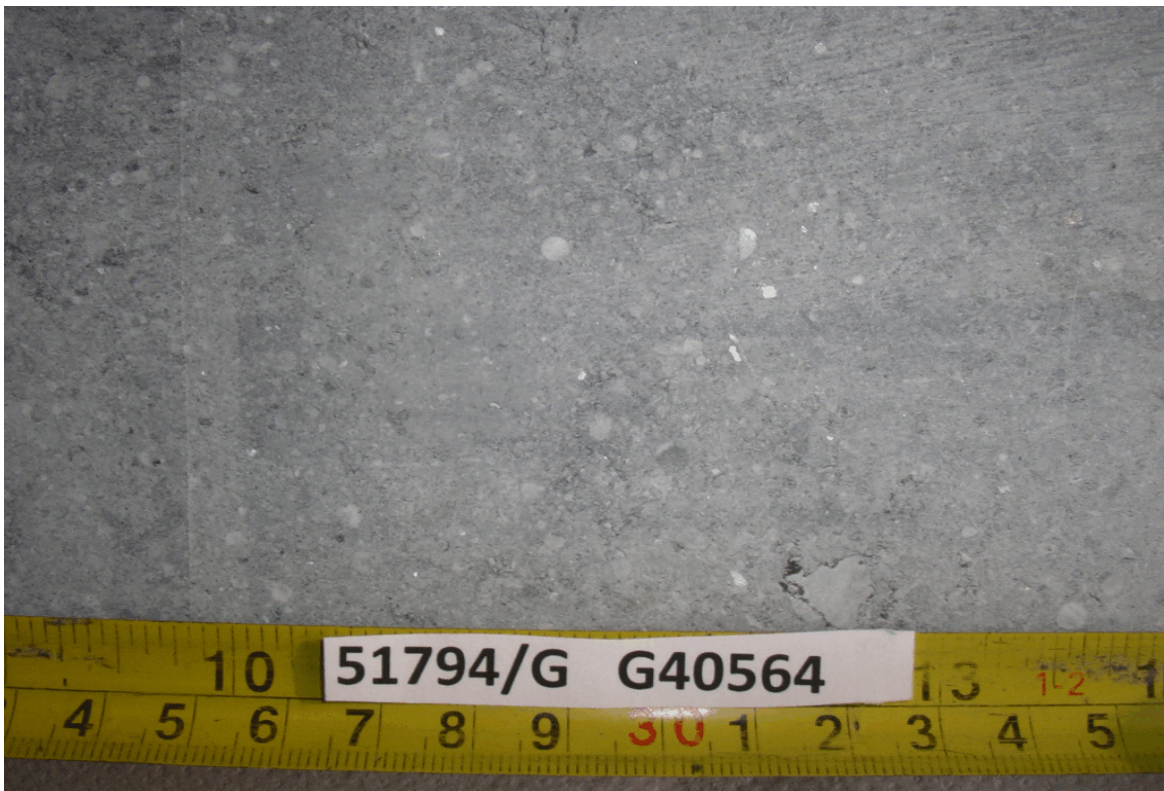
G40564 : Threecastles limestone. Close-up.

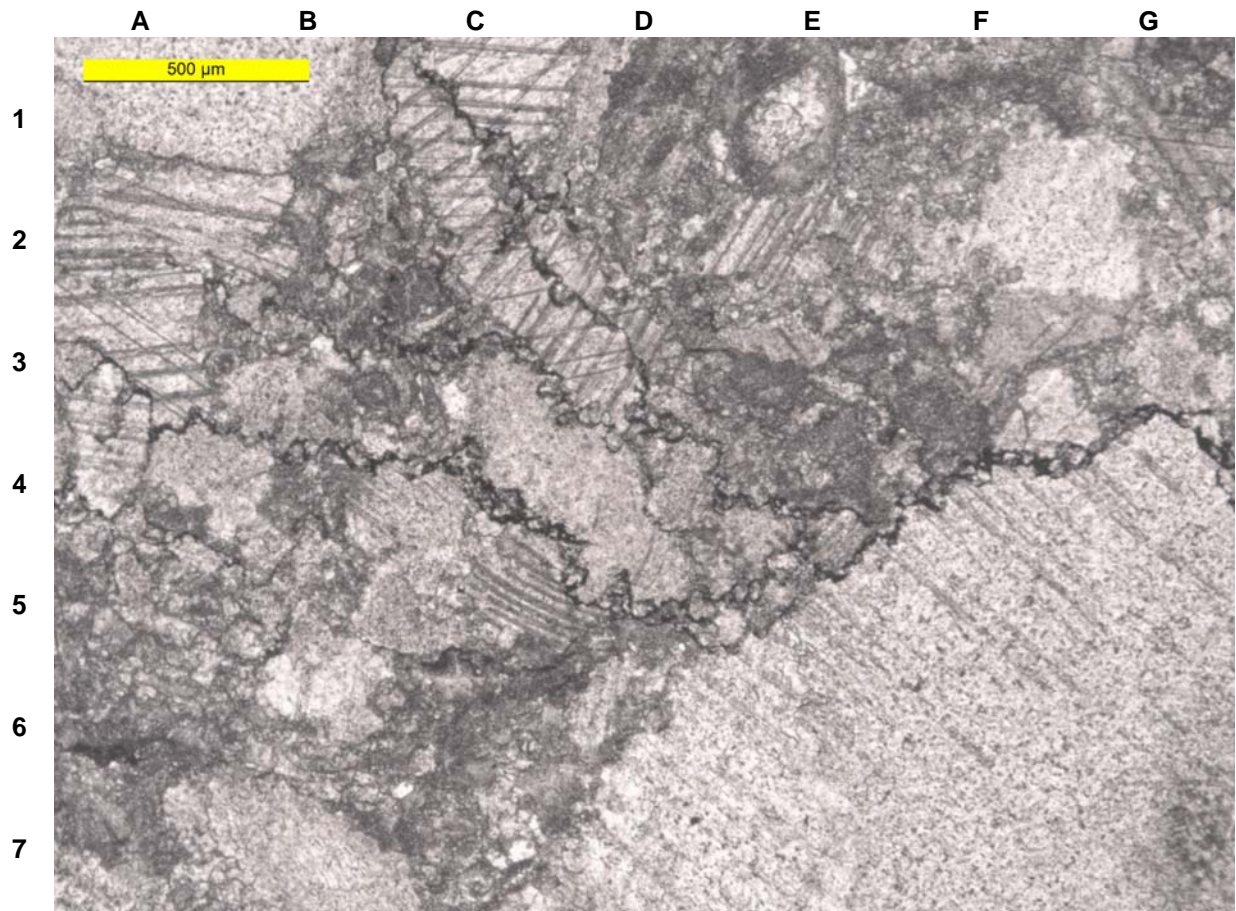
51794/G
Table/Sheet
1/3
Plate
1

Photomicrograph Details			
Sandberg Sample Ref:	G40564	Client Ref/Site Mark:	Threecastles limestone
Microscope Light:	Plane polarised	Objective Magnification:	x5
Photomicrograph Description			
<p>General view of the stone structure. In the field of view there is relict bioclastic debris (e.g. B/7, B-C/4-5, etc.) and sparry calcite (e.g. C/1-2, A/2, etc.) exhibiting rhombic cleavage. Stylolitic seams are the sutured black lines.</p>

A representative portion from the sample was used to prepare a large area thin section which was examined using a Leica DM4500P high power petrological microscope employing plane polarised and cross polarised light at magnifications up to x1000.

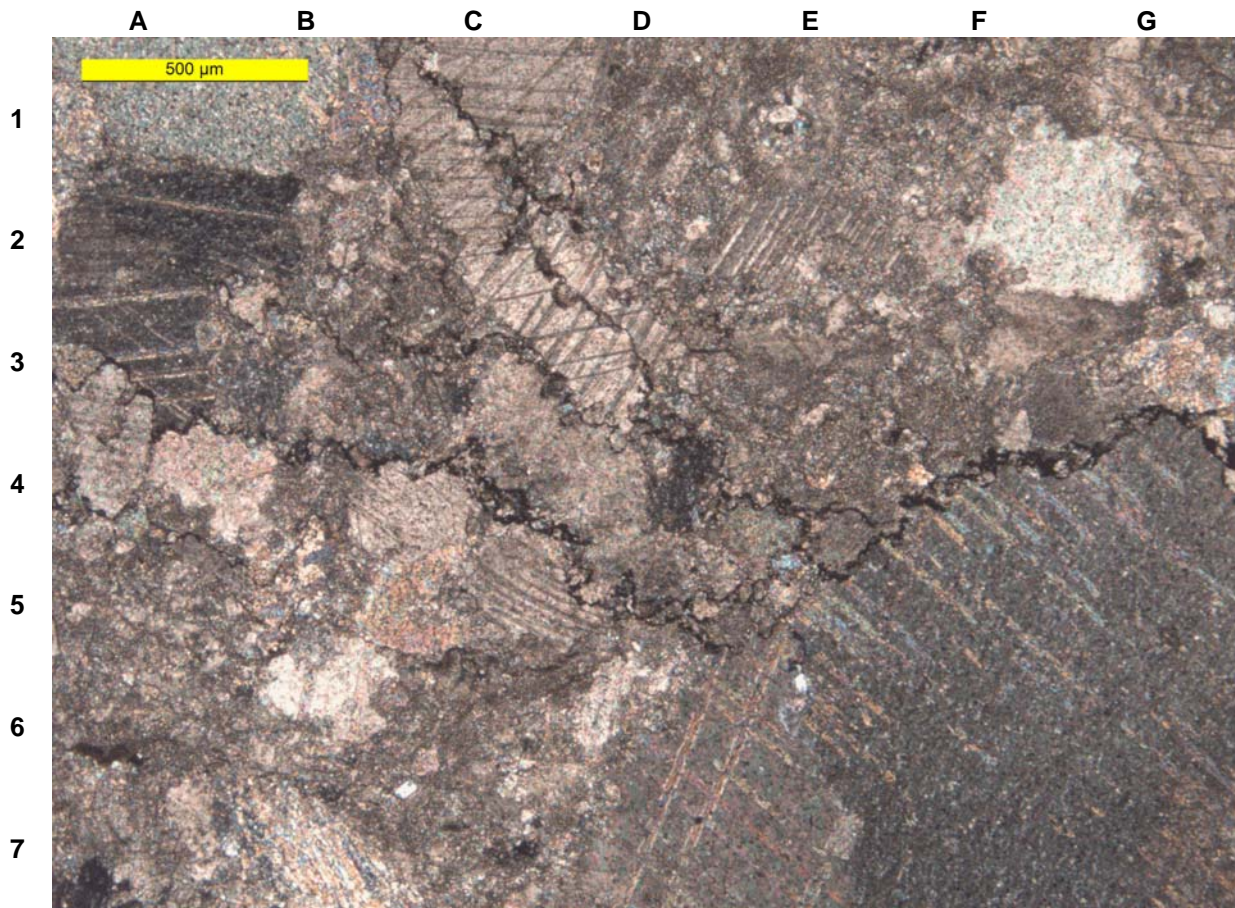
51794/G
Table/Sheet
1/4
Plate
2

Photomicrograph Details			
Sandberg Sample Ref:	G40564	Client Ref/Site Mark:	Threecastles limestone
Microscope Light:	Cross polarised	Objective Magnification:	x5
Photomicrograph Description			
<p>General view of the stone structure. In the field of view there is relict bioclastic debris (e.g. B/7, B-C/4-5, etc.) and sparry calcite (e.g. C/1-2, A/2, etc.) exhibiting rhombic cleavage. Stylolitic seams are the sutured black lines.</p>
